***Bracing For the Future:  
Construction Techniques to Protect Against  
Future Wind Damage in Ladysmith***

***FEMA-DR-1432-WI  
September 2002 Tornadoes***

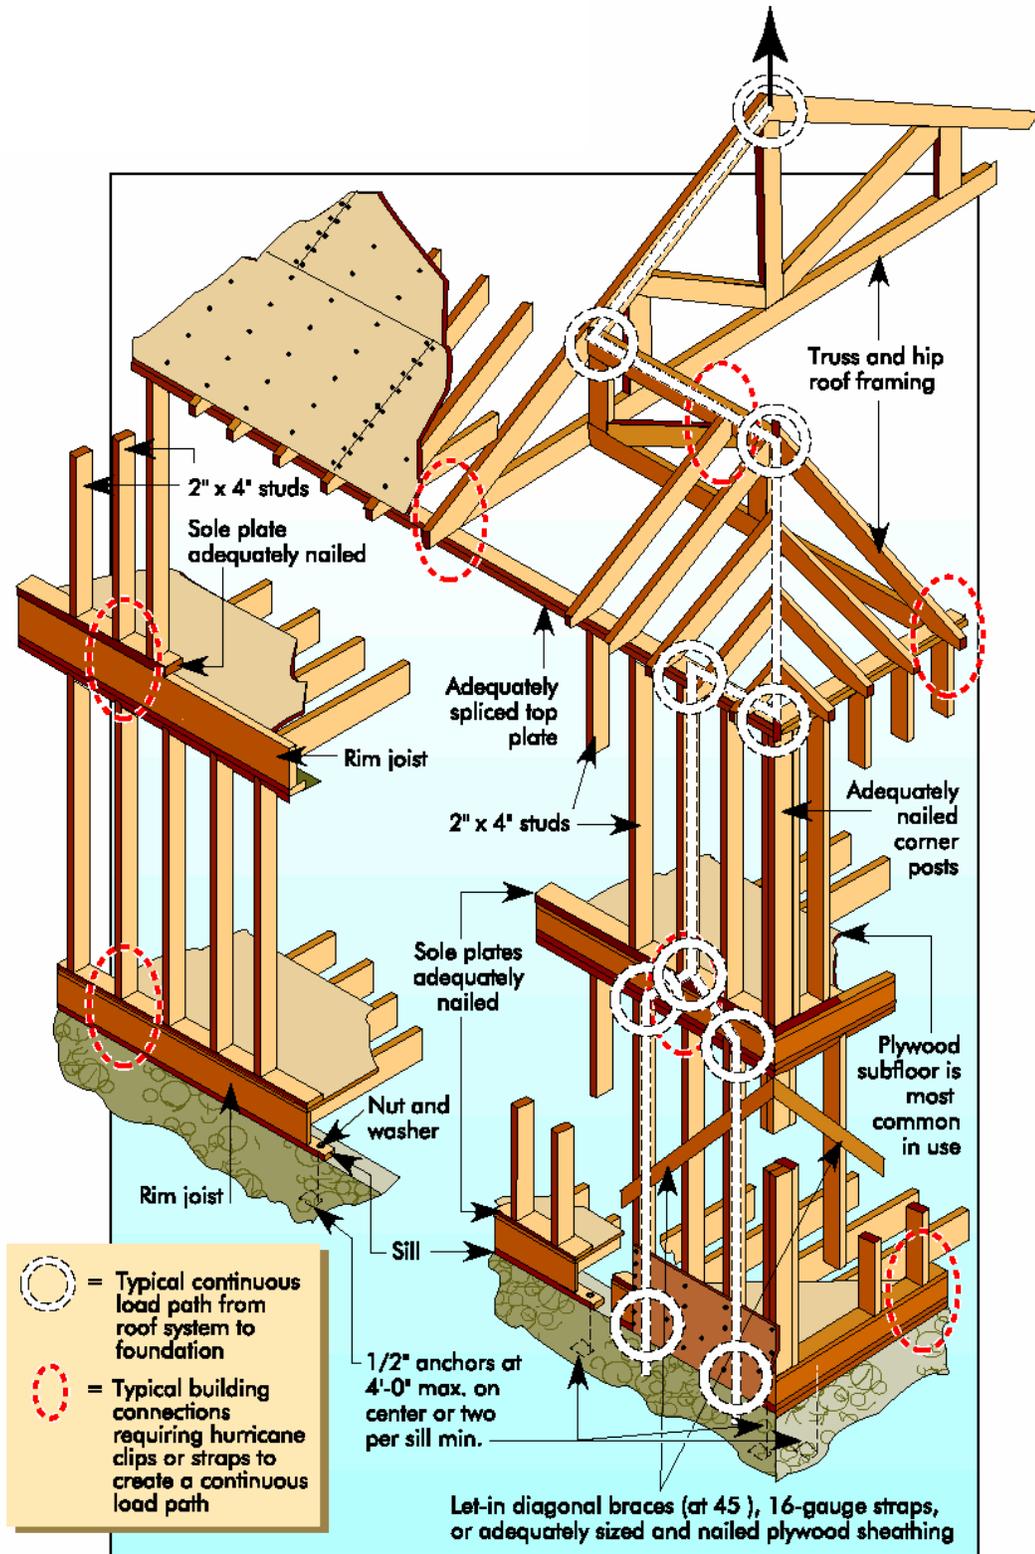
Figure R-1. Continuous load path in a typical 2-story wood frame residential structure. A continuous load path resists uplift and lateral loads that act on a building (From FEMA 342).

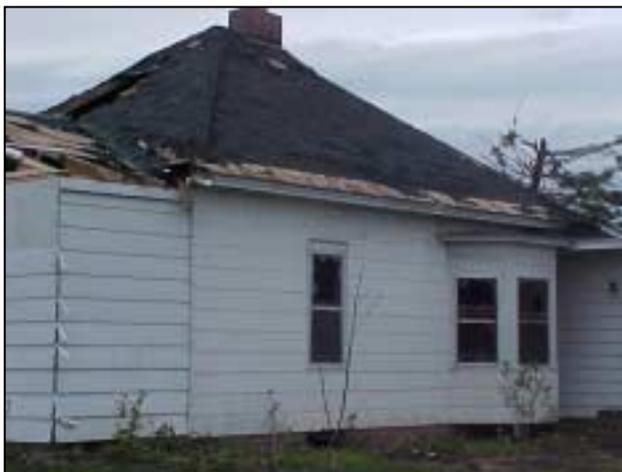
**Figure R-2. Loss of roof shingles beginning at roof edge.  
 (507 Lake Avenue, Ladysmith)**

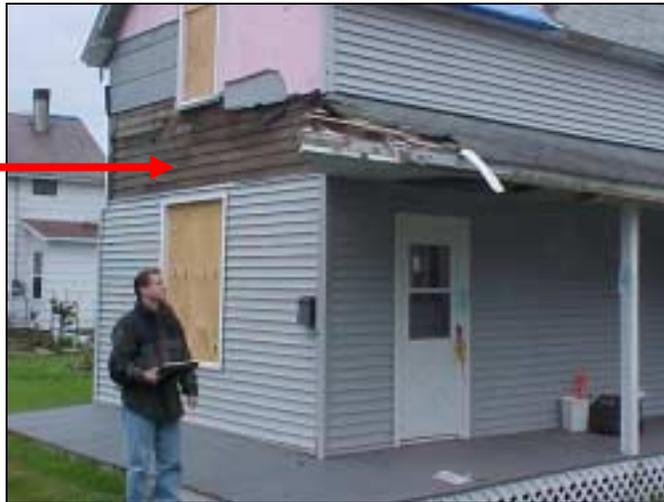
**Figure R-4. Failure of overhanging porch roof.**  
(923? Lake Avenue, Ladysmith)

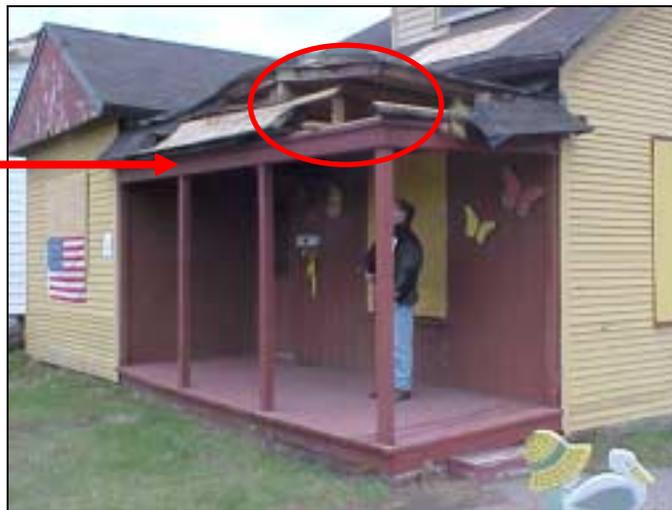
**Figure R-5. Damage to overhanging porch roof.**  
(421 Lake Avenue, Ladysmith)

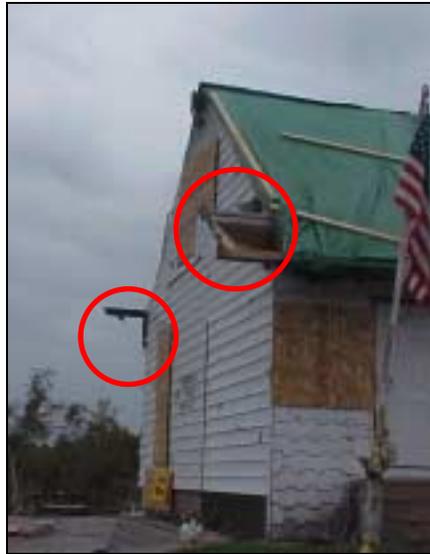
**Figure R-6. Large overhang roof failure.**  
(307 Lake Avenue, Ladysmith)

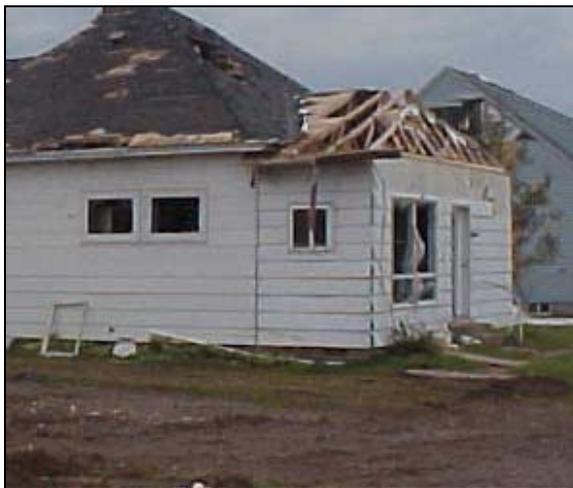
**Figure R-7. Hip roof success, gable end roof failure**

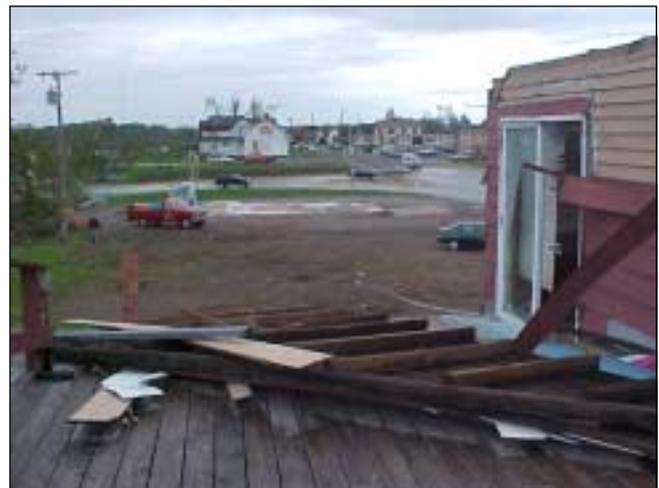
**Figure R-8. Gable end wall was pulled off of building.**  
(Lake Avenue, Ladysmith)

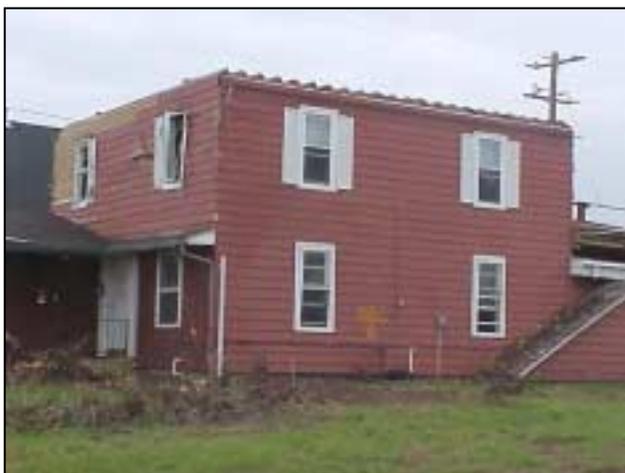
**Figure R-9. Wood-frame house with missing wood roof due to poor connection at top of wall. (Multi-family house on Lake Avenue, Ladysmith)**

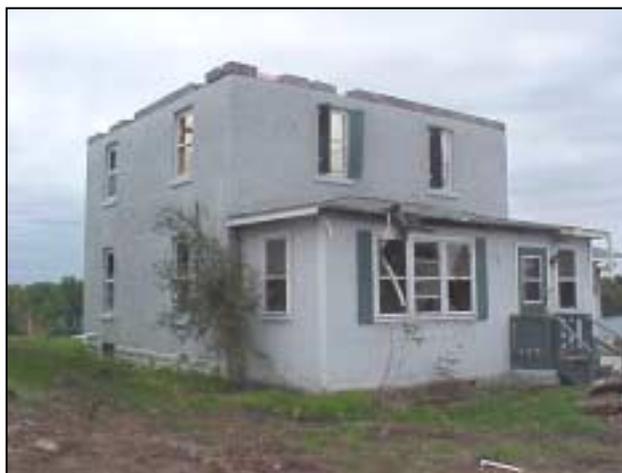
**Figure R-10. Masonry house with missing wood roof due to poor connections. (607 Lake Avenue, Ladysmith)**

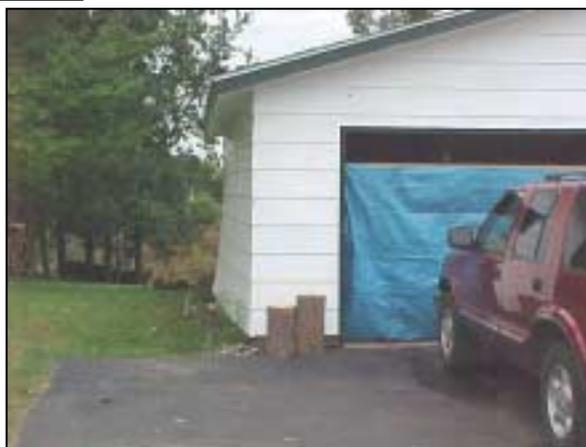
**Figure R-11. Garage door failure led to deformation of garage wall. (800 Menasha Avenue, Ladysmith)**

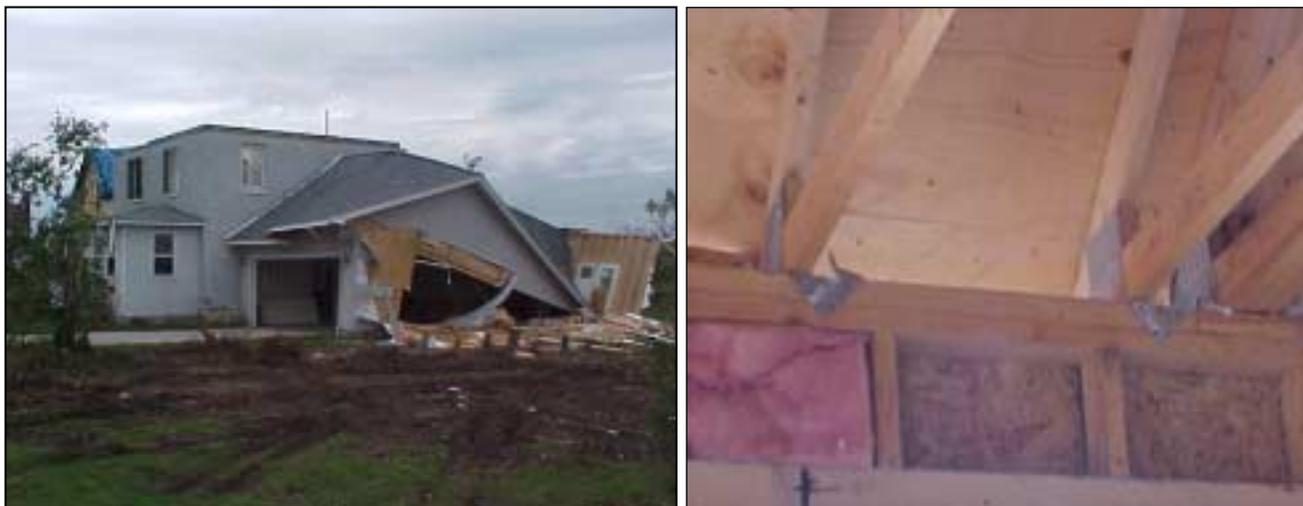
**Figure R-12 and R-13. Loss of garage door allowed wind inside garage. Roof trusses in garage moved from original position. Nails were used to secure clip to wall top plate, but no nails connected the clips to the trusses (607 Lake Avenue, Ladysmith).**

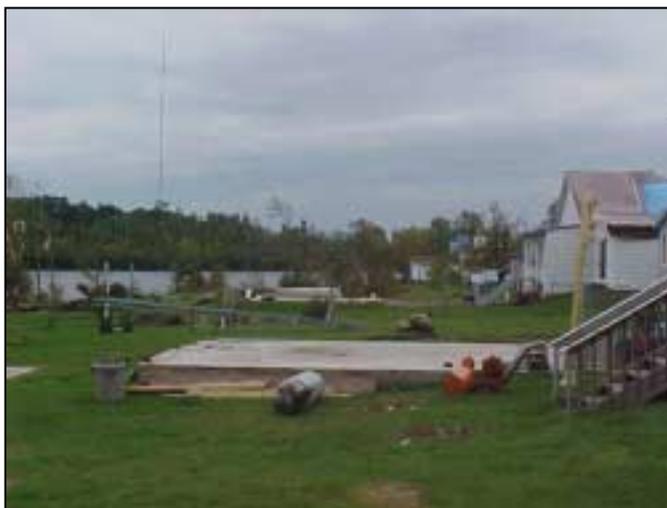
**Figure R-14. Storage sheds and garages destroyed due to poor anchorage to foundations. (Residences along Lake Avenue, Ladysmith)**

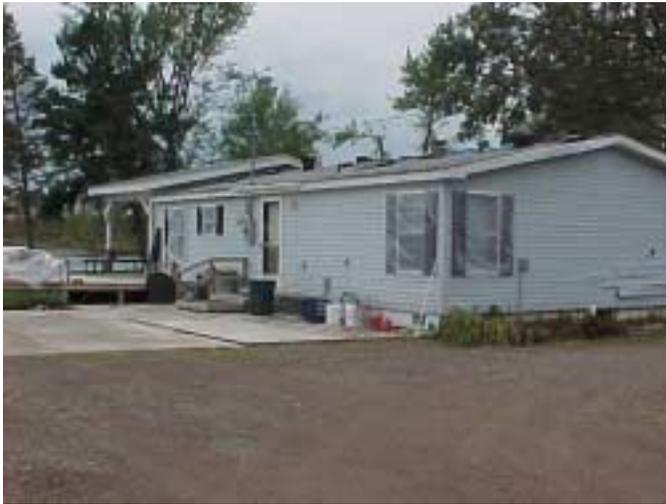
**Figure R-15. Windows damaged and covered with plastic (700 River Street, Ladysmith)**

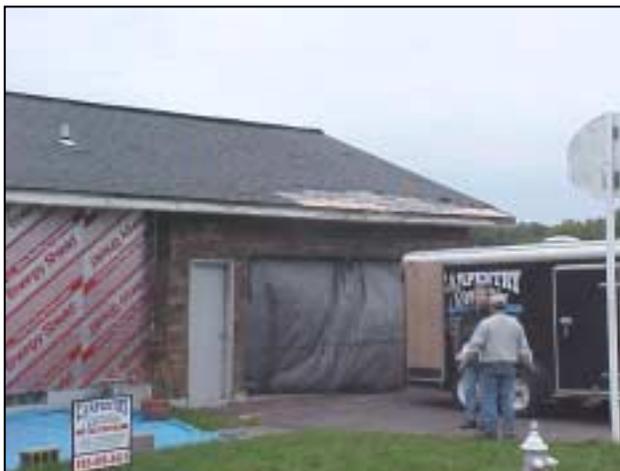
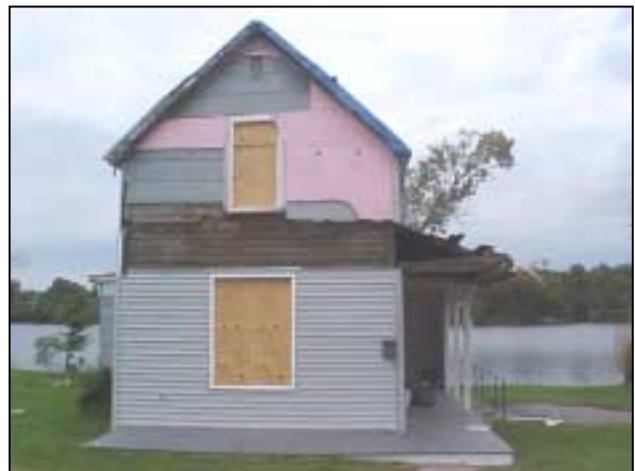
**Figures R-16 and R-17. Loss of exterior wall covering under repair (721 and 923 Lake Avenue, Ladysmith)**

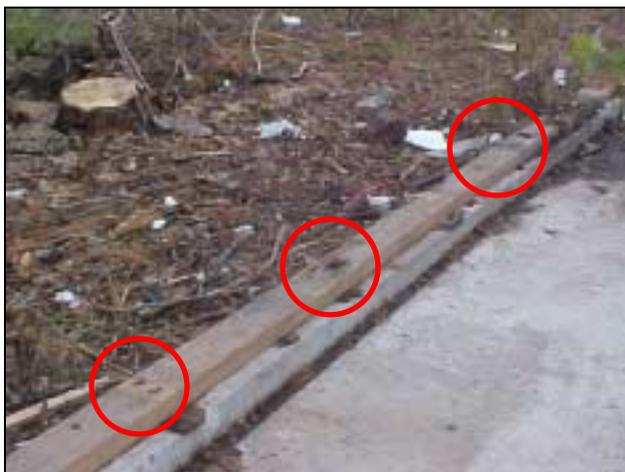
**Figure R-18. Failed wall connection to sill plate at a detached garage. Toe nail marks from wall studs are circled. (415 Lake Avenue detached garage, Ladysmith)**

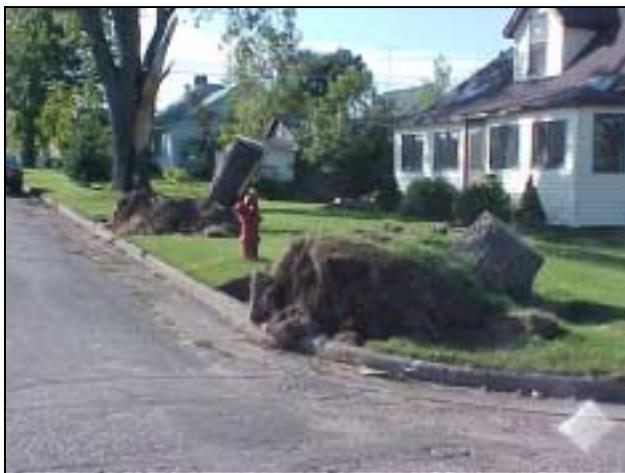
**Figure R-19: Uprooted trees in foreground, splintered tree in background (Corner of E10th Street and Miner Avenue, Ladysmith)**

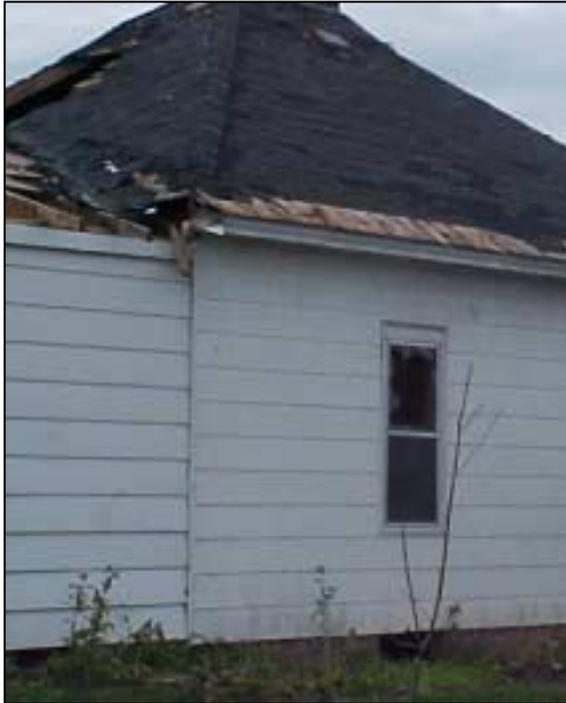
**Figure R-19. Typical roof covering damage along roof edge. (507 Lake Avenue, Ladysmith)**

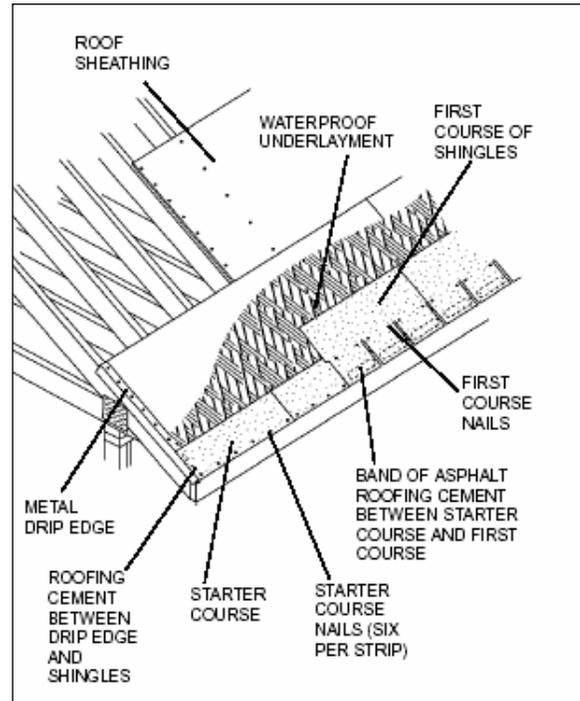
**Figure R-20. Details for strengthening roof coverings (FEMA How-To Series, [www.fema.gov](http://www.fema.gov))**

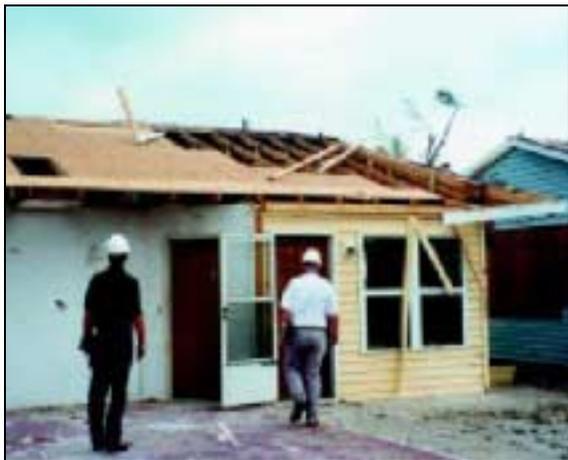
Screws, nails, and staples are inexpensive construction materials. Contractor costs for installation, however, will vary based on the time and effort necessary to expose the existing connections and perform the necessary work.

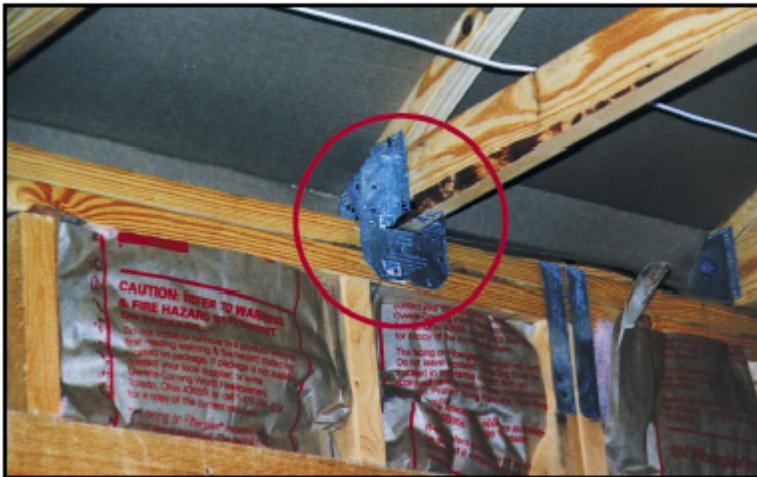
Figure R-23. Properly clipped roof truss at top of wood frame wall (FEMA 55CD, Third Edition *Coastal Construction Manual*).

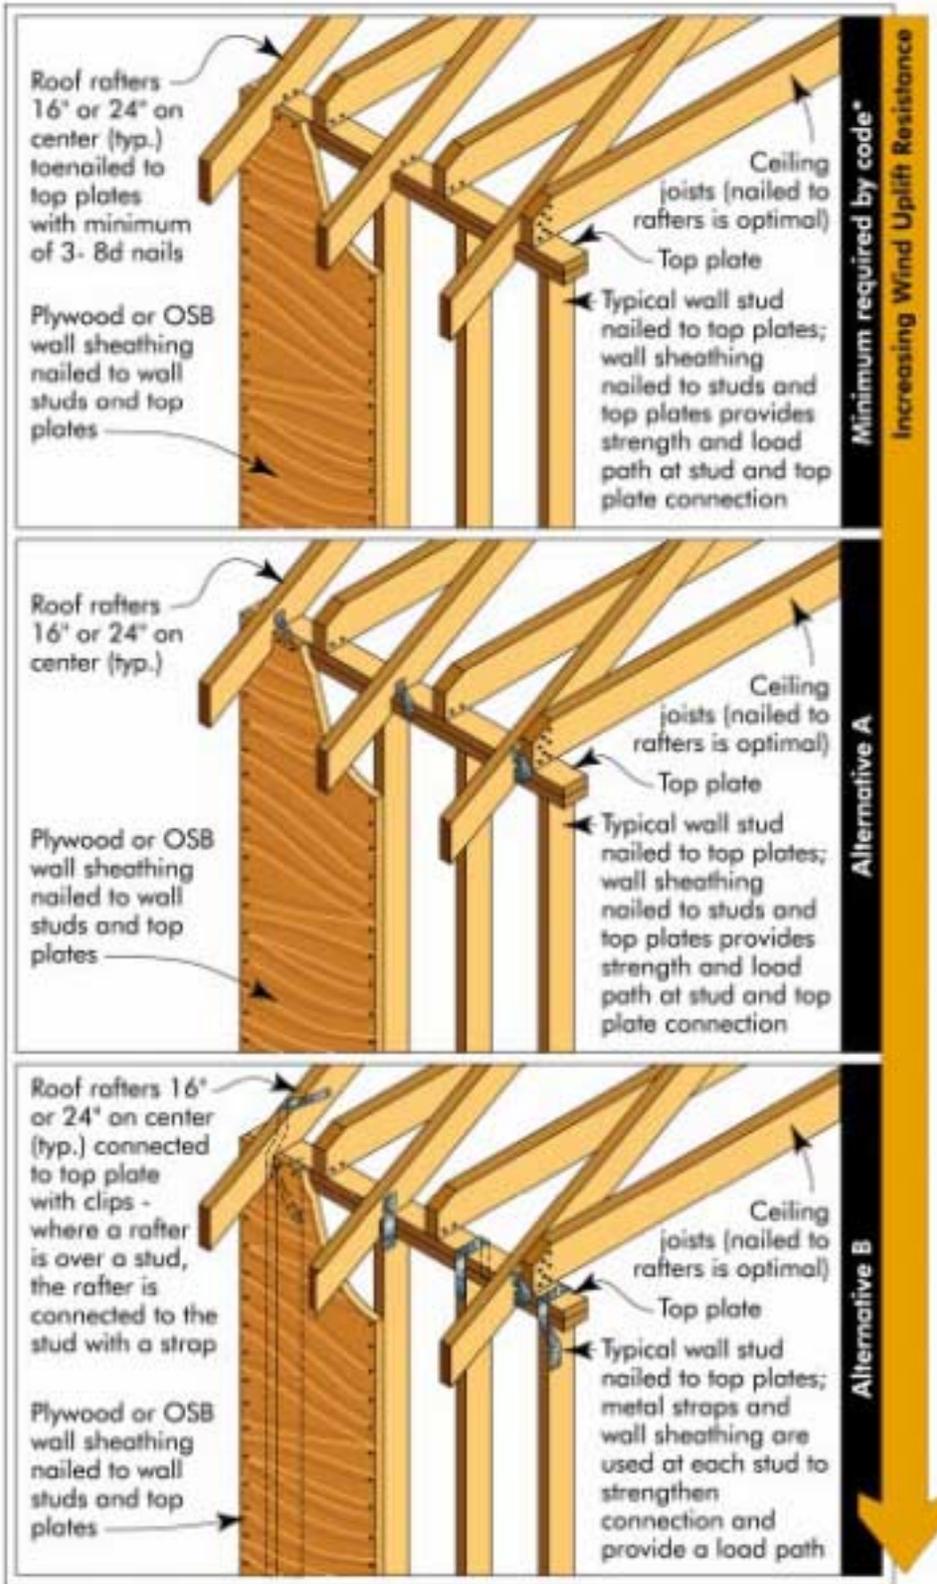
Figure R-24. Details for attached roof rafters to wood frame wall systems. The minimum allowed (top option) may only be used when roof spans are less than 6 feet. When spans are longer, Alternatives A and B are recommended (FEMA 342).

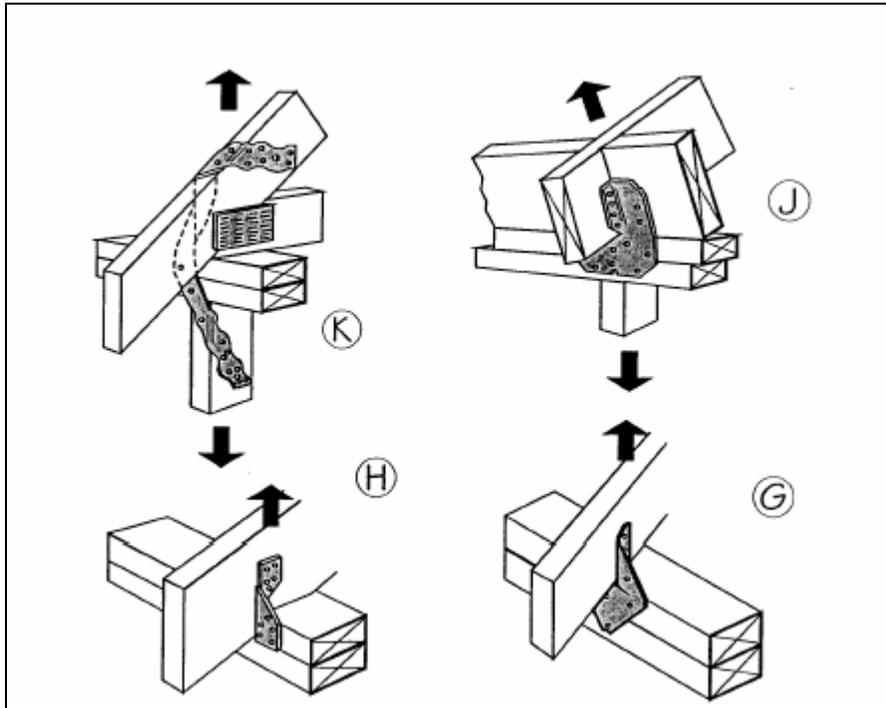
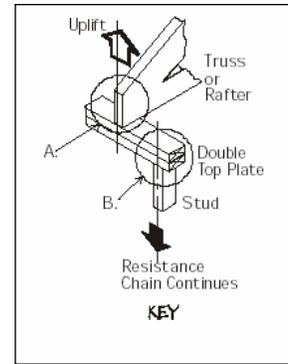
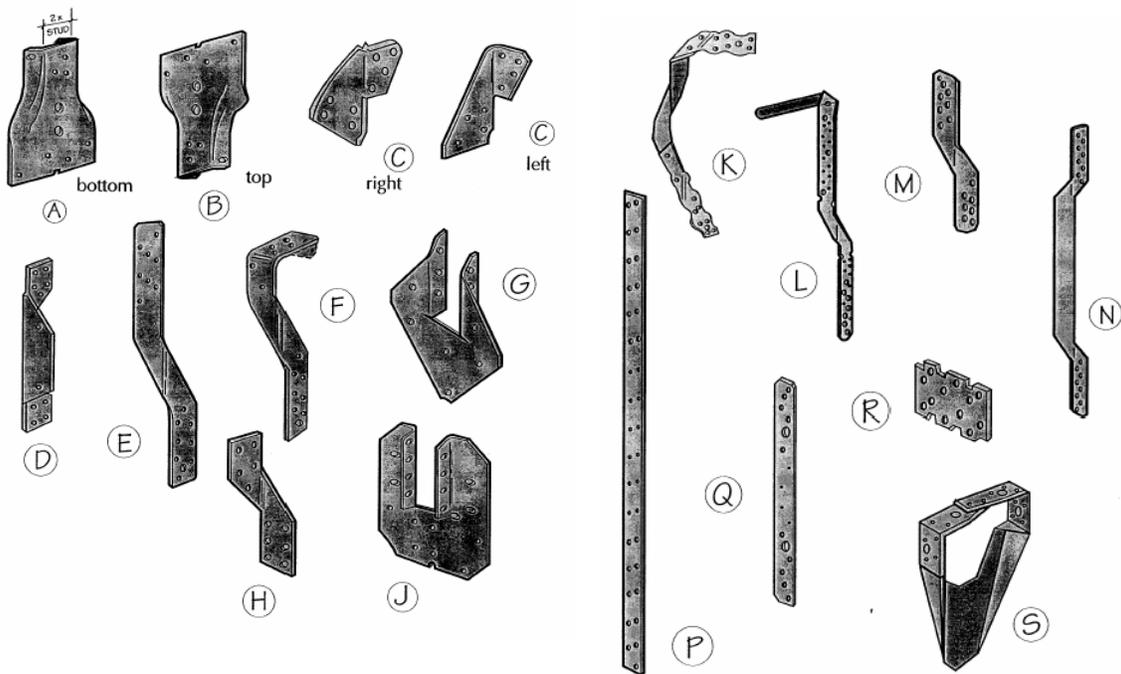
Figures R-25a, 25b, and 25c. Improved roof frame to wall connection details shown as the the clips as attached to framing, the forces the clips are designed to resist, and the clips alone.  
(Illinois EMA, Windstorm Mitigation Manual for Light Frame Construction, August 1997)

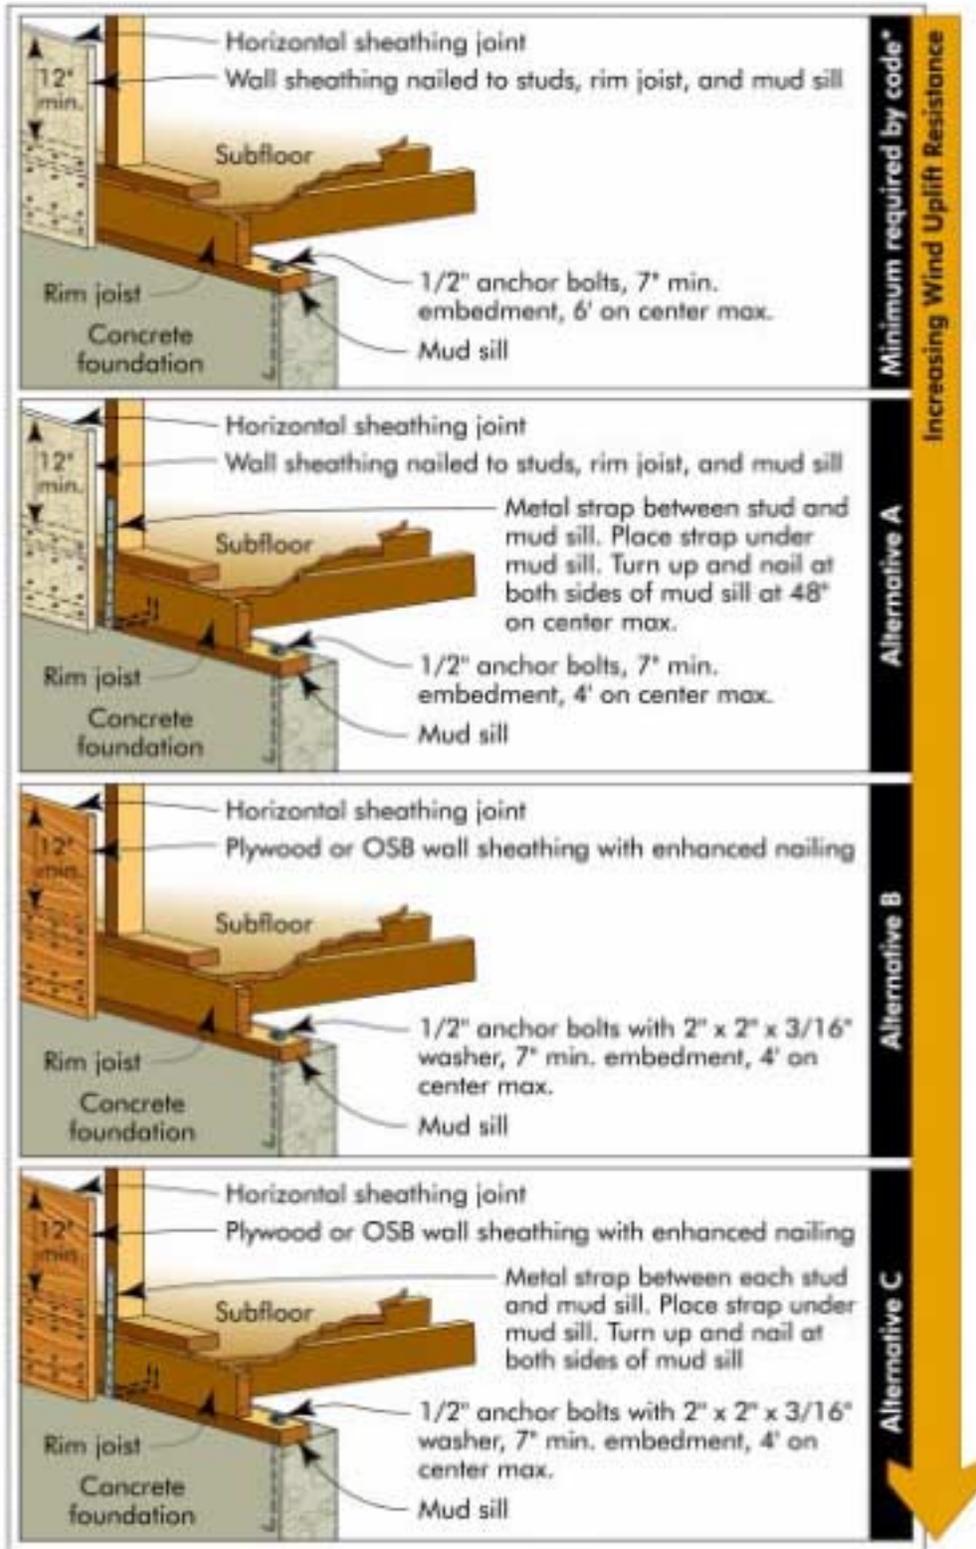
Figure R-27. Details for attached wall framing and sill plates to the house foundation. The minimum connections required by code is the top option, alternatives providing additional strength increase from Alternatives A to C (FEMA 342).

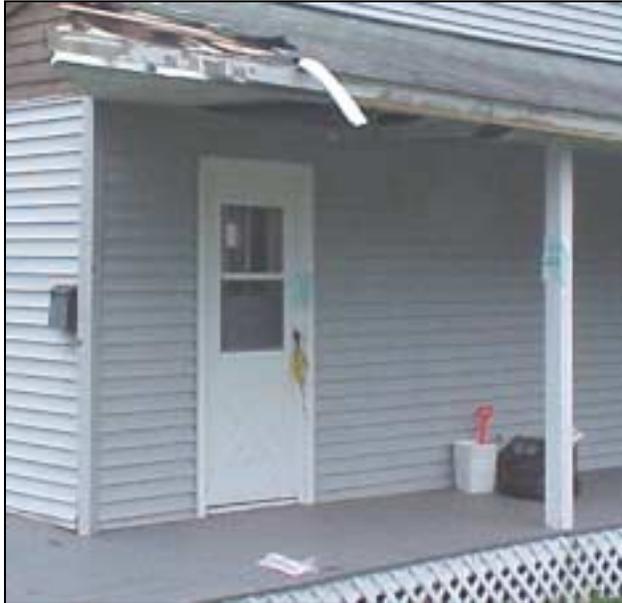
Typical EPC  
End Post Cap  
Installation

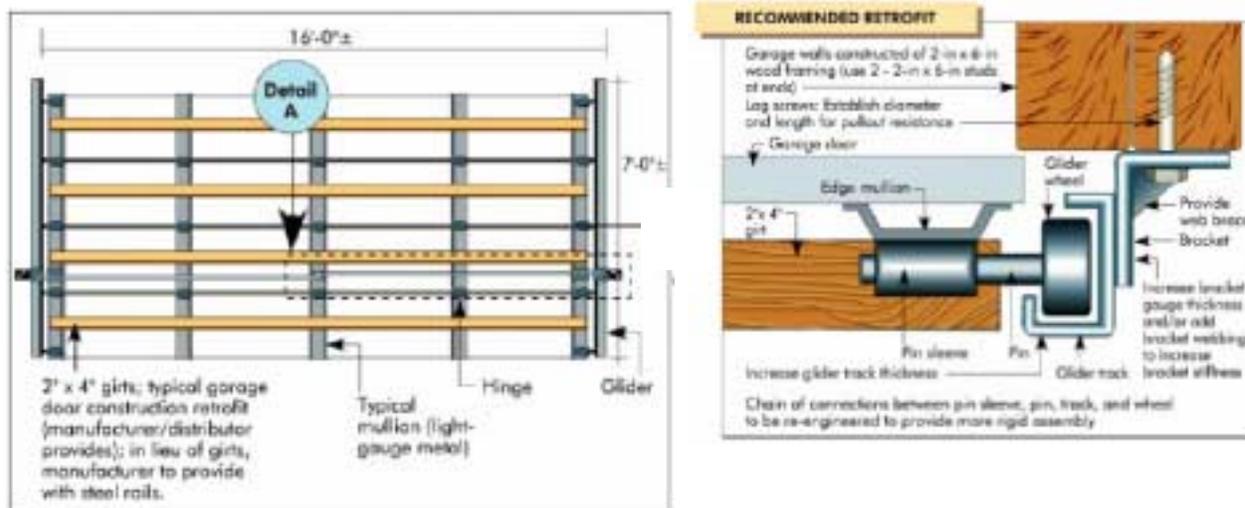
Figures R-32 and R-33 showing placement of wood 2"x4" wood girts to reinforce garage door (left) and recommended retrofit for door track assembly (right) (From FEMA 342).

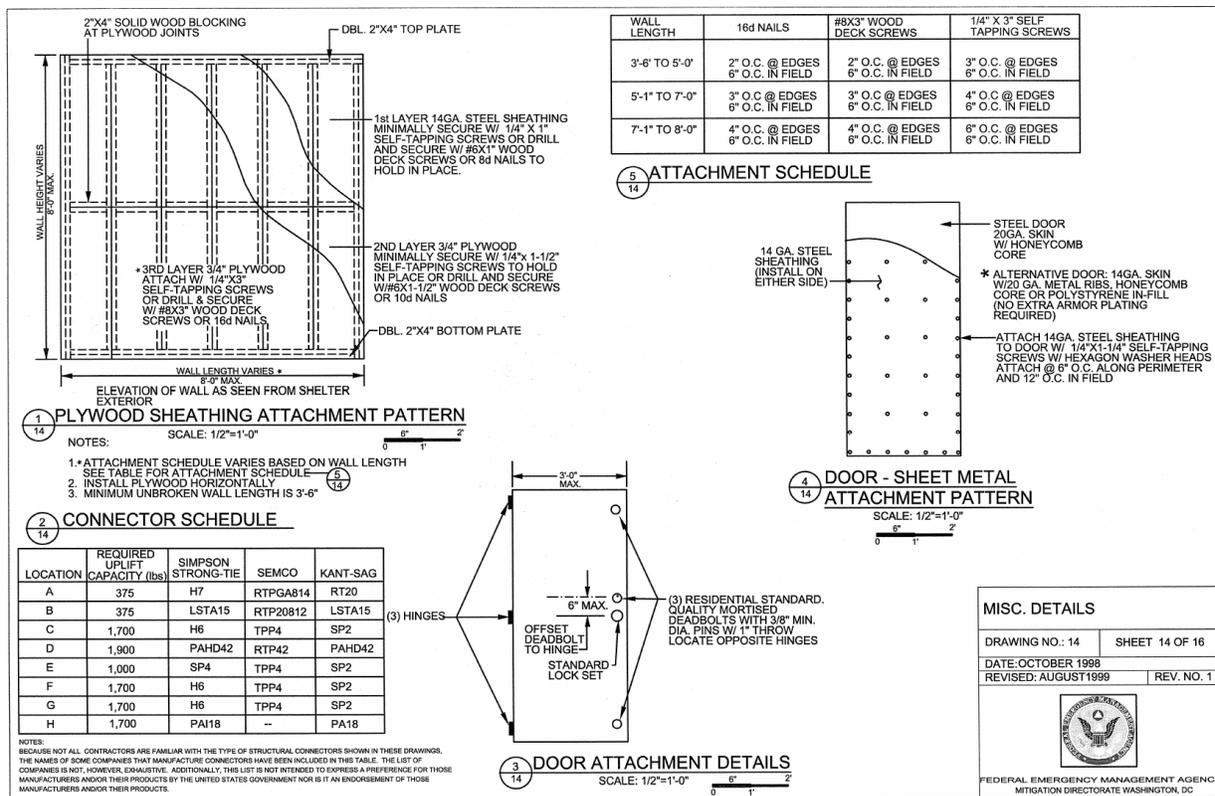
Figure R-36. Sheeting attachment detail sheet from FEMA 320.

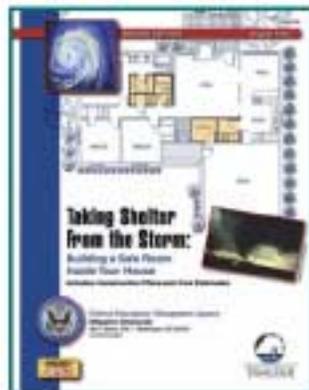
In-residence shelters can typically be installed in an existing home for **\$3,000 to \$6,000**, depending on the size and location of the shelter. Detailed design plans for in-residence shelters are available from FEMA Publication 320, *Taking Shelter from the Storm*.

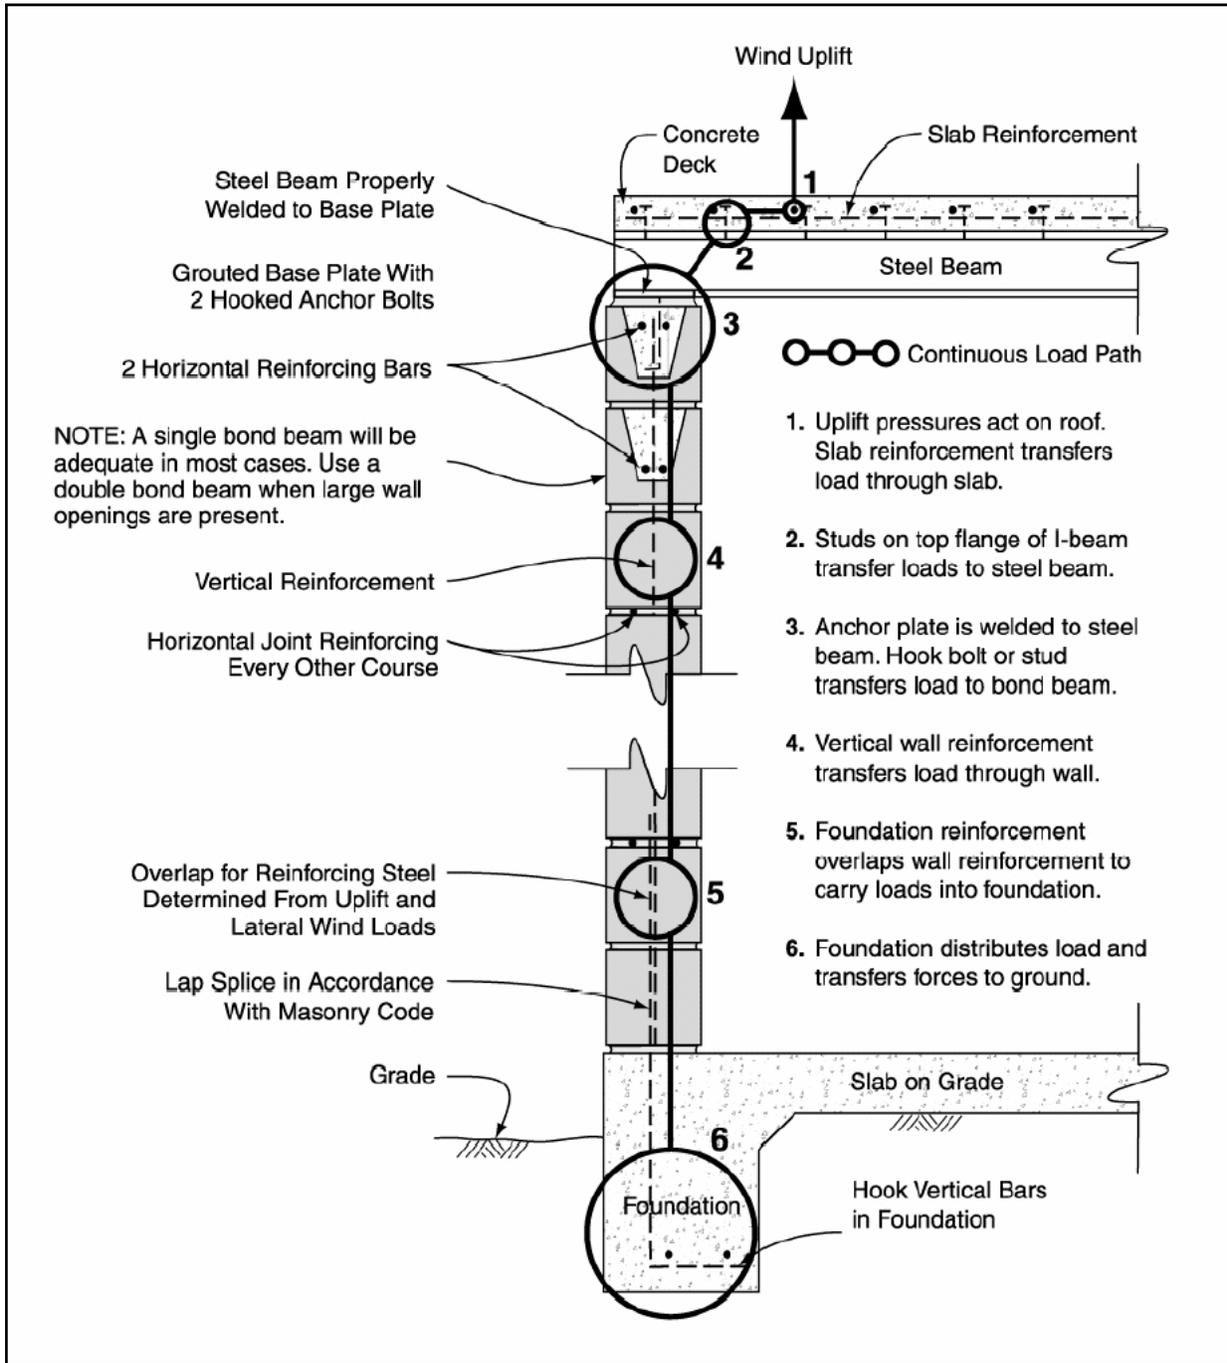
Figure C-1. Example of a continuous load path in a masonry wall accomplished with reinforcing steel and proper connections. The solid line depicts the continuous load path and the circles identify critical connections.

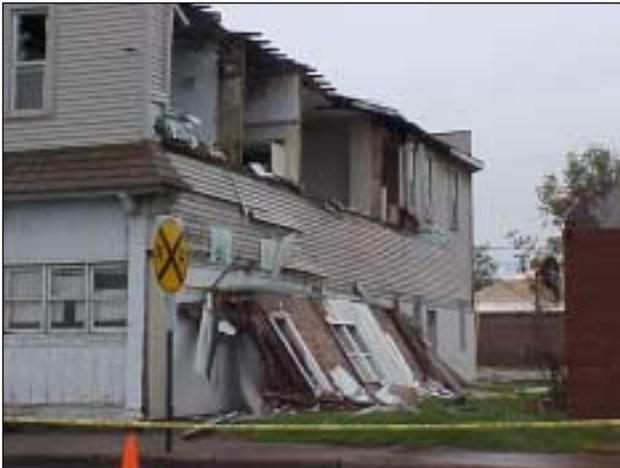
during a high wind event, and mechanical fasteners are needed to anchor the roof trusses to the walls. Most wood frame structures were constructed prior to the adoption of the 2000 International Building Code (IBC) which requires wind loads to be considered. As a result, most commercial buildings of this construction type were damaged because of a lack of a continuous load path. Even though some structures were intact after the 2002 event, those buildings remain vulnerable to wind event damage if mitigation measures are not implemented.

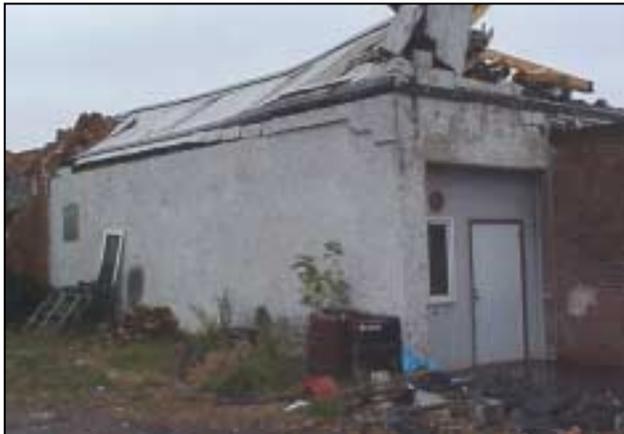
**Figure C-3. Second story masonry wall failure. Wall failed from lateral wind pressure probably after roof was separated from structure.**

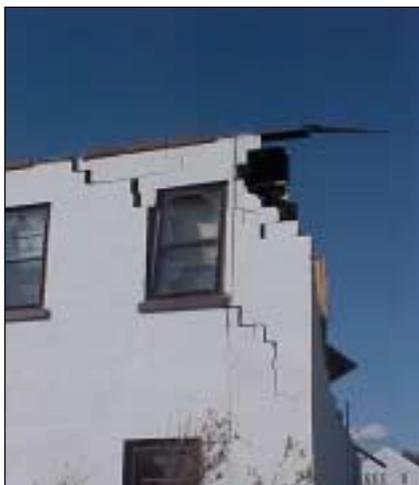
**Figure C-4. Second story masonry wall damage. Uplift on roof caused step cracking in wall.**

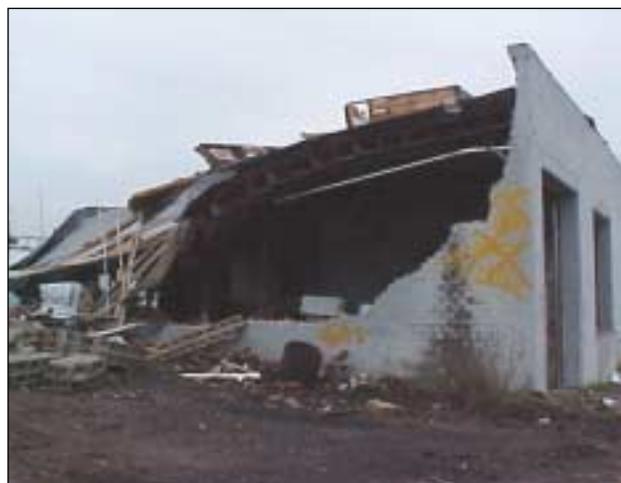
**Figure C-5. First floor masonry wall failure. Wall failed from lateral wind pressure probably garage door failed.**

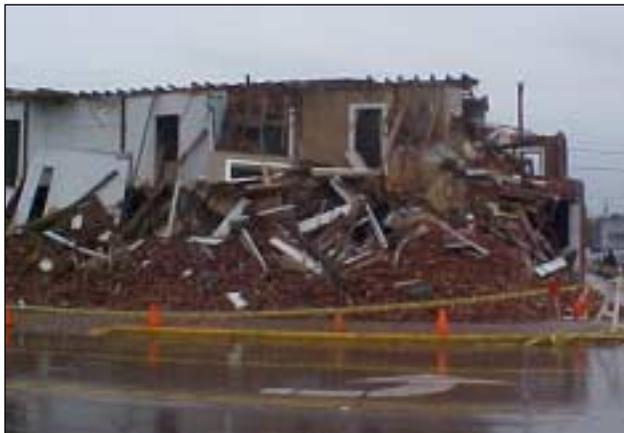
**Figure C-6. Completed failure of 1<sup>st</sup> and 2<sup>nd</sup> story unreinforced brick masonry walls.**

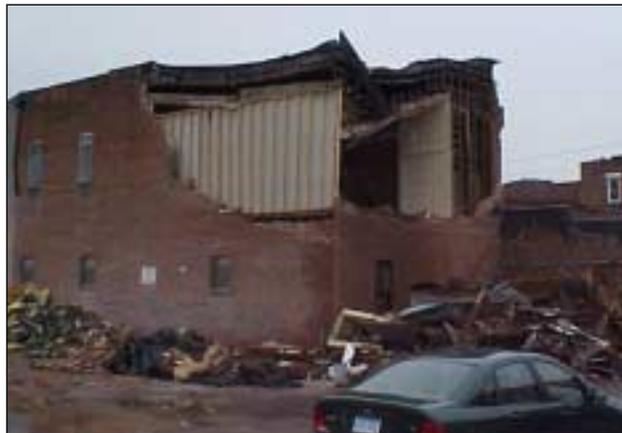
**Figure C-7. Failure of 2<sup>nd</sup> story brick masonry walls from lateral wind forces.**

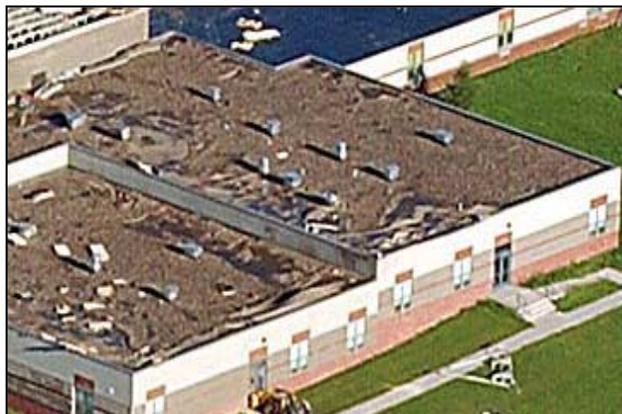
**Figure C-8. Roof ballast is missing along roof edges.**

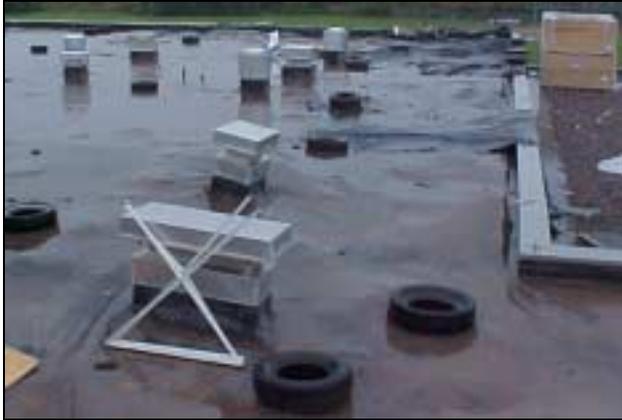
**Figure C-9. Uneven roof decking and roof insulation and displaced roof vents above classrooms.**

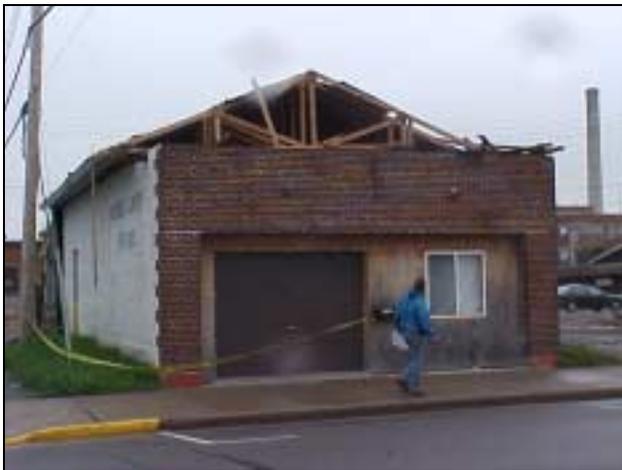
**Figure C-10. Gable end wood roof with decking failure. Loss of decking may have lead to instability and failure of end trusses.**

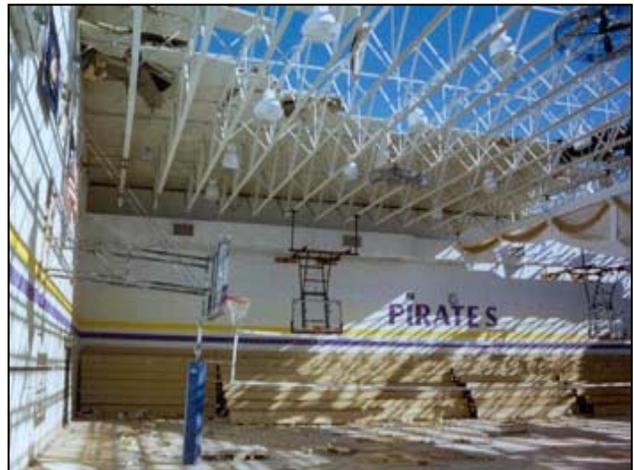
**Figure C-11. Tectum roof deck loss at the Gilman School (Courtesy of the Gilman School).**

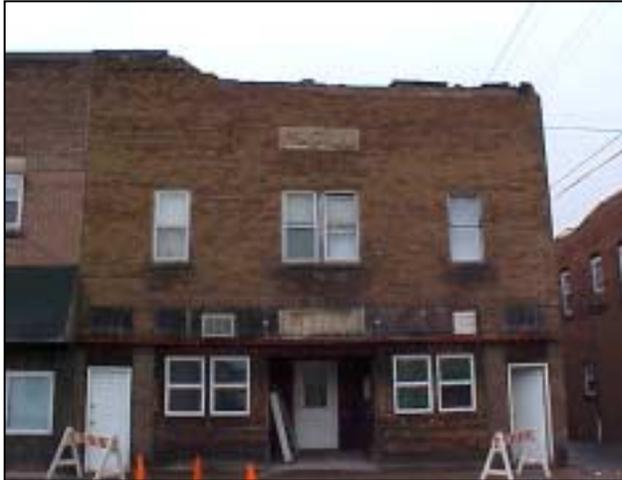
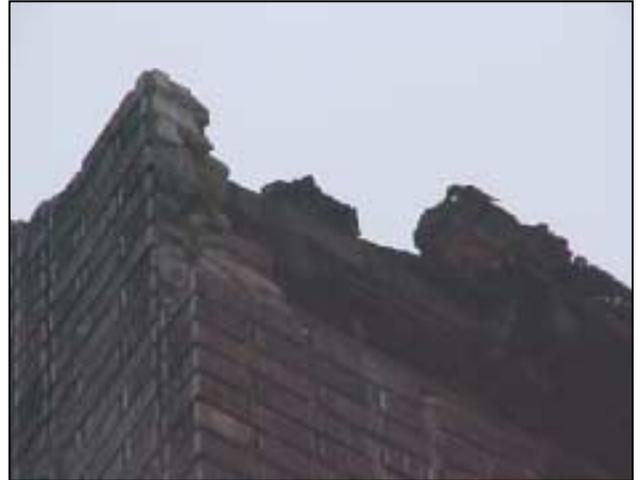
**Figures C-12 and C13. Masonry parapet failure over and entranceway (left) and masonry parapet failure that led to partial collapse of exterior wall (1<sup>st</sup> street and 111 Minor Ave, Ladysmith).**

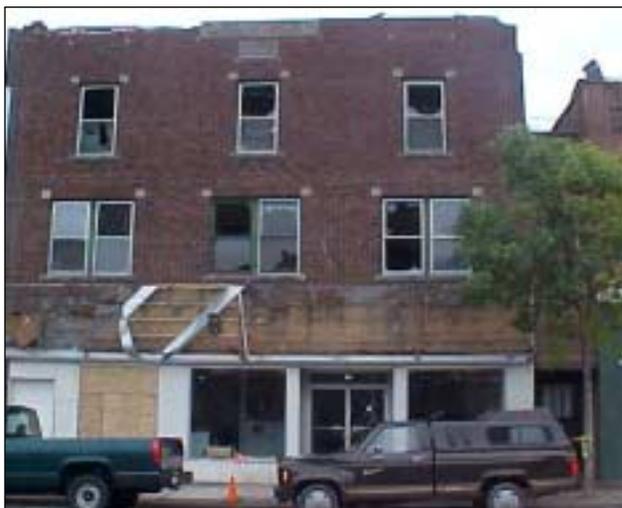
**Figures C-14. Typical window damage to commercial buildings.**

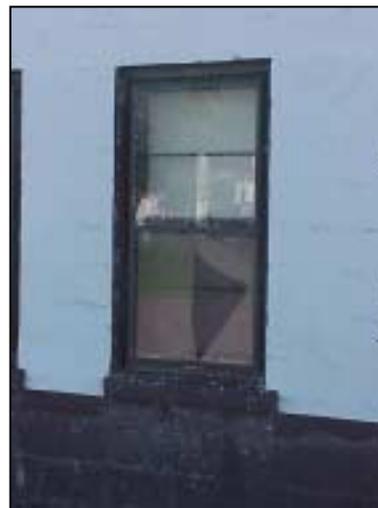
**Figure C-15. Exterior window pane is broken, but interior window paint is intact.**

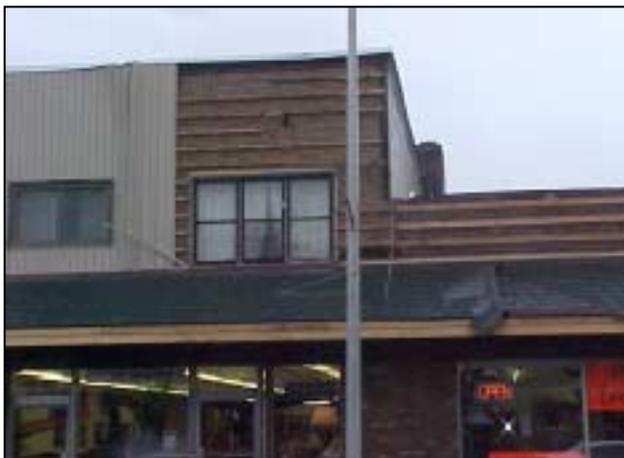
**Figure C-16. Siding damage from wind suction forces.**

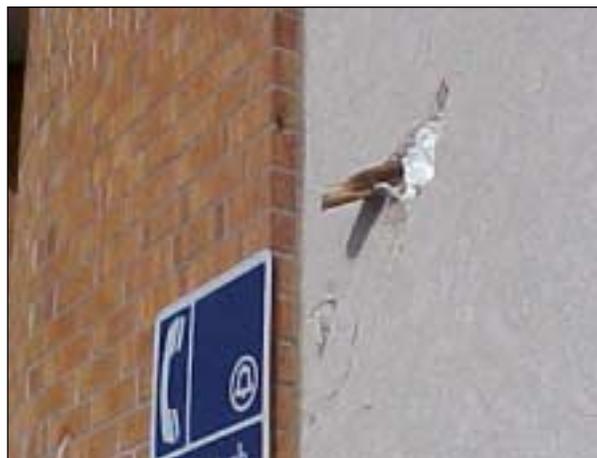
**Figure C-17. Windborne debris impacted into EIFS wall system.**

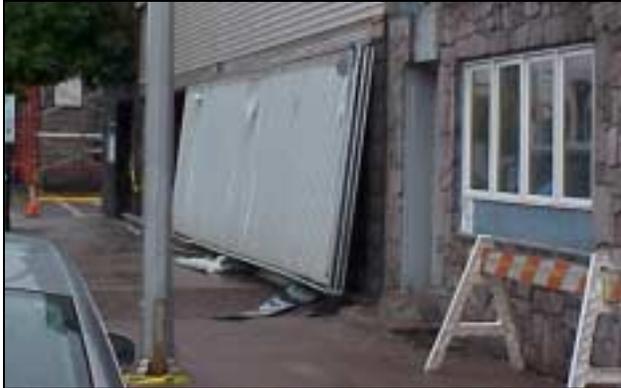
**Figure C-18. Damaged store awning. The cantilevered awning failed from wind uplift forces.**

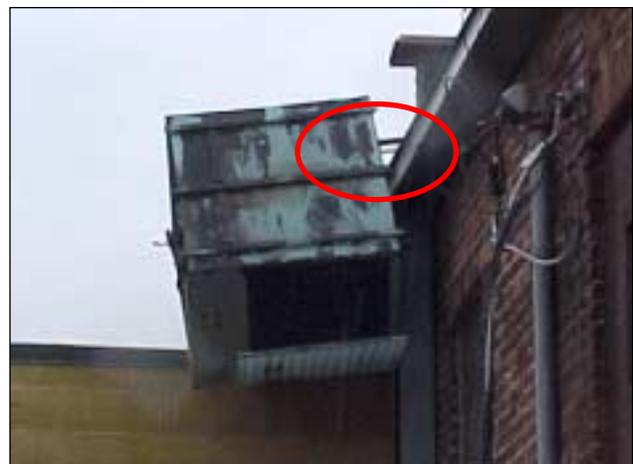
**Figure C-19. Roof top unit removed from roof by wind forces. Electrical conduit is all that has kept this unit from falling completely off the roof.**
