***Bracing For the Future:  
Construction Techniques to Protect Against  
Future Wind Damage in Ladysmith***

***FEMA-DR-1432-WI  
September 2002 Tornadoes***

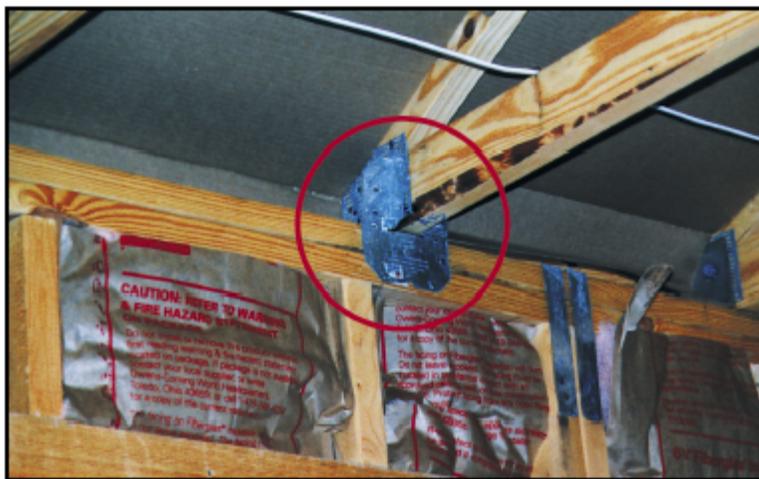
**Figure C-20. Properly clipped roof truss at top of wood frame wall. (FEMA 55CD, Third Edition *Coastal Construction Manual*)**

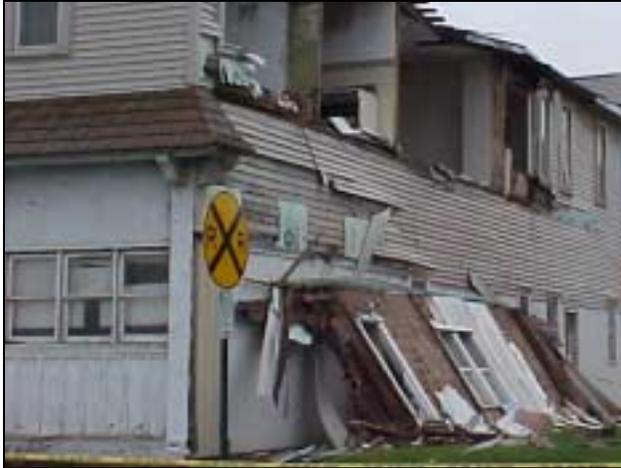
Figure C-21. Second floor wood framing failure.  
 (Minor Ave. Ladysmith)

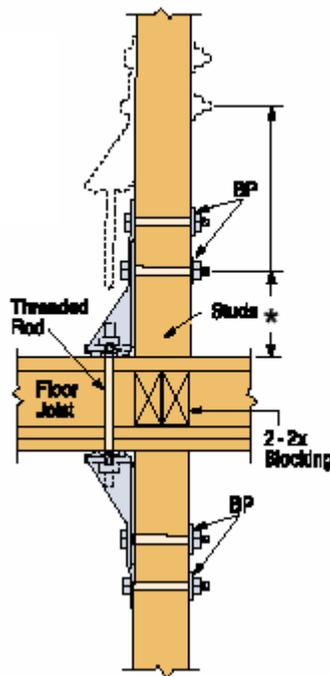
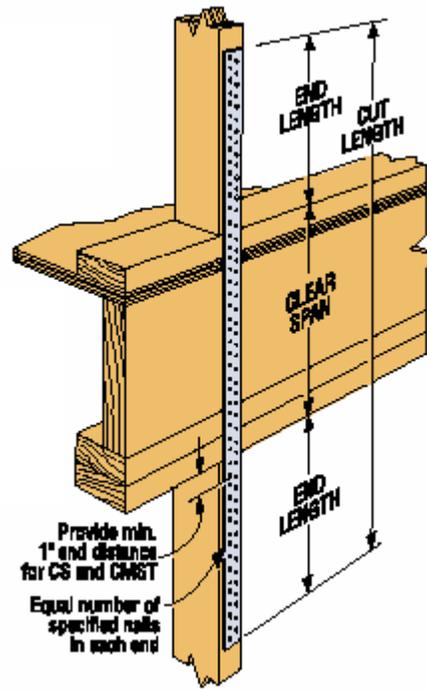
Figures C-22 and C-23. Examples of mechanical fasteners providing continuous load path across floor systems. From the 2002 Simpson Strong-Tie Catalog. Mechanical fasteners may be used from any manufacturer as long as an engineer verifies that they provide adequate strength for the predicted loads.

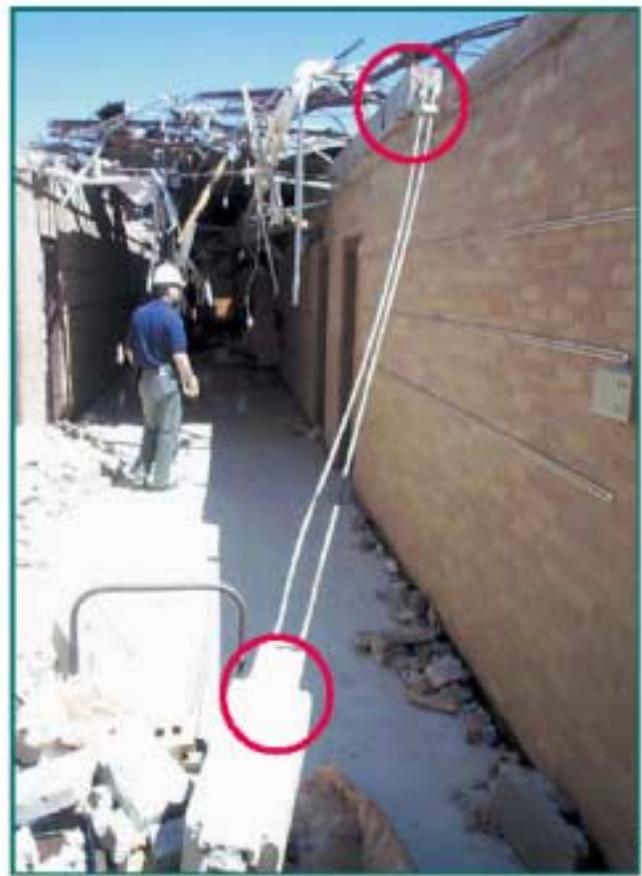
**Figure C-24. Bond beam detached from top of CMU wall (with brick veneer). There was no connection between the bond beam and the top of the wall. (From FEMA 342).**

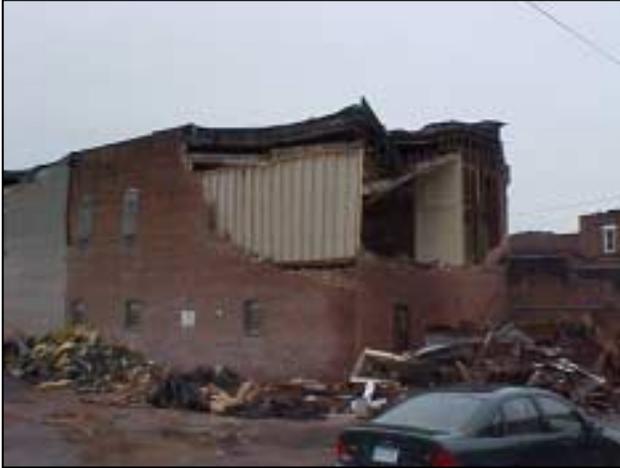
**Figure C-26. Typical second story brick masonry failure. (between xx Avenues, Ladysmith)**

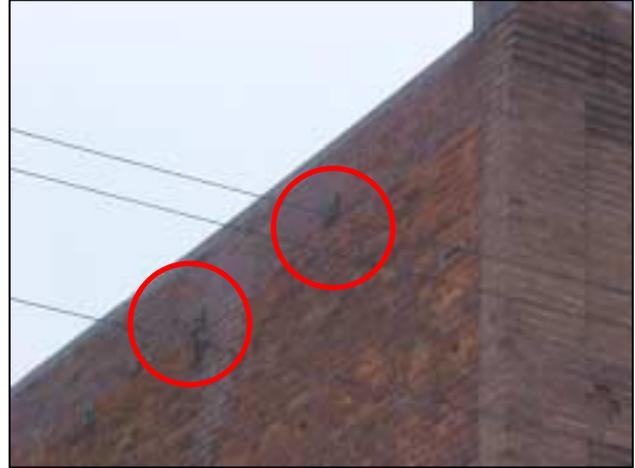
**Figure C-27. Brick masonry wall reinforcing on upper story of building (Minor Avenue, Ladysmith)**

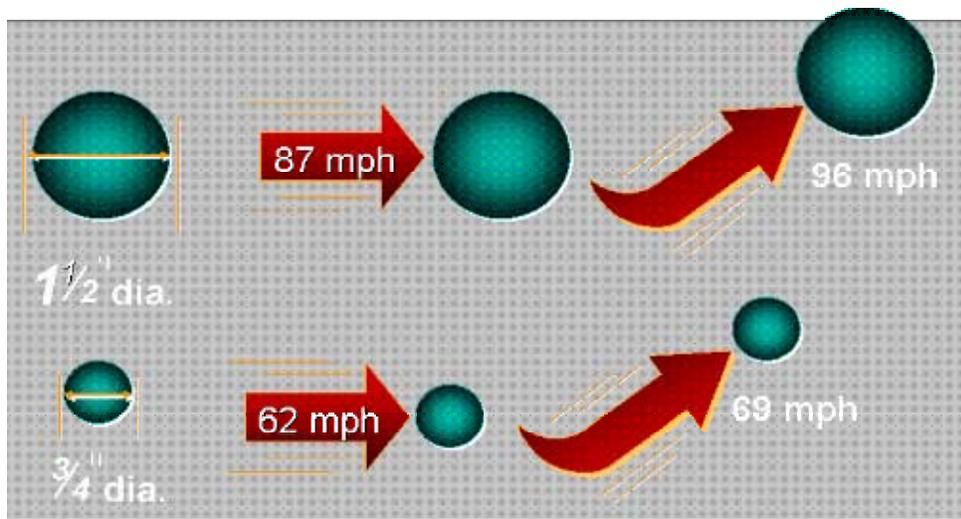
**Figure C-28. Wind speed required to displace and lift aggregate roof ballast into the air.**

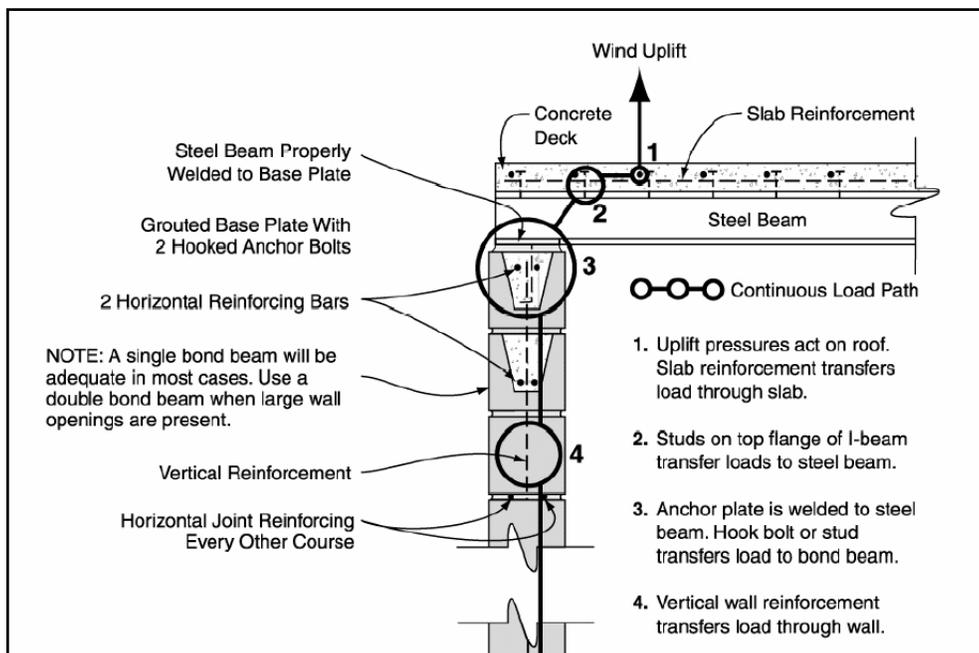
Figure C-29. Example of a continuous load path from a roof deck to the top of a reinforced masonry wall.

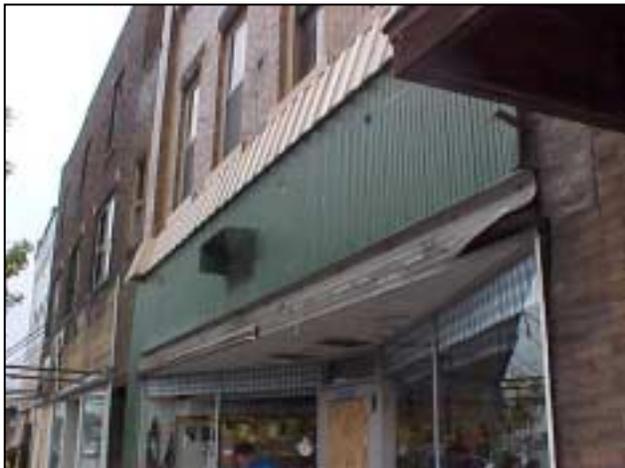
**Figures C-30. Awning damage in foreground and intact awning framing in background.**

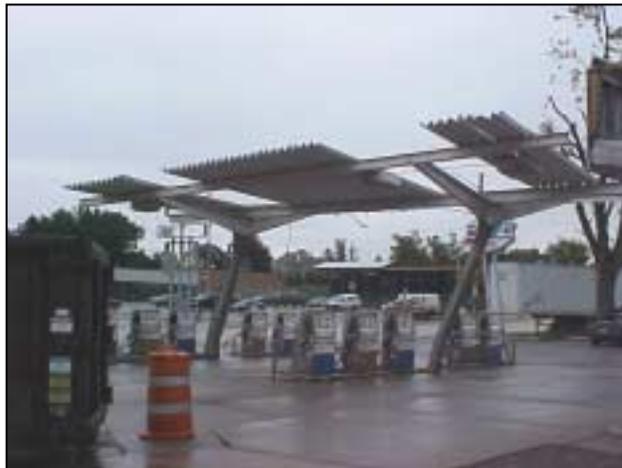
**Figure C-31.. This gas station canopy can be replaced with a new canopy designed to resist high winds.**

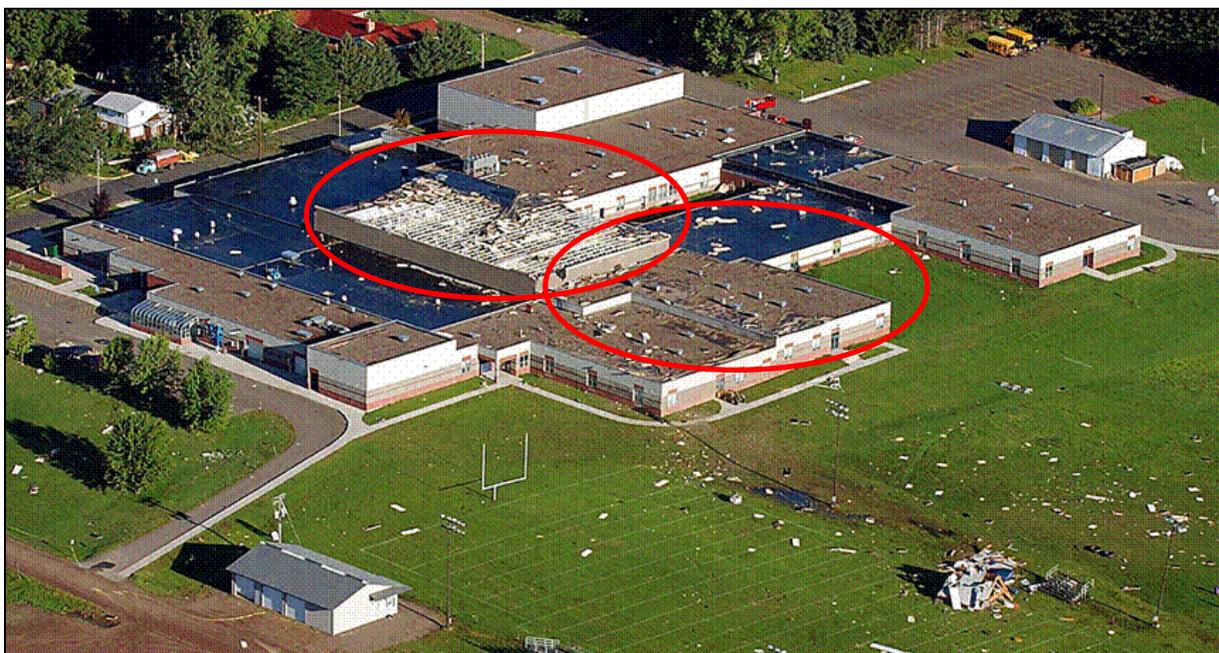
**Figure S-1. Damage to the Gilman School. Damaged gymnasium and classrooms are circled (Photo by the Eau Claire Leader-Telegram).**

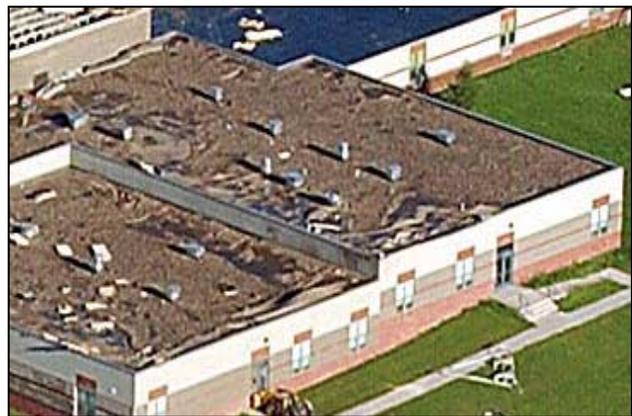
**Figures S-2. Damaged roof at Gilman School. Ballast is missing along edge sections of the roof where wind forces are the highest.**

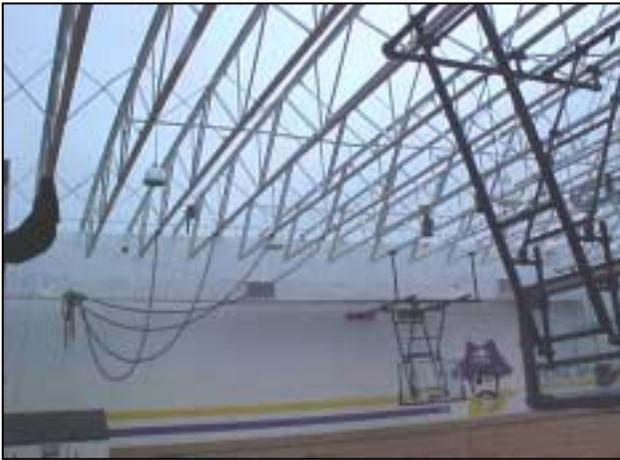
**Figures S-3. Missing roof decking in the gymnasium. It should be noted that these walls did not collapse.**

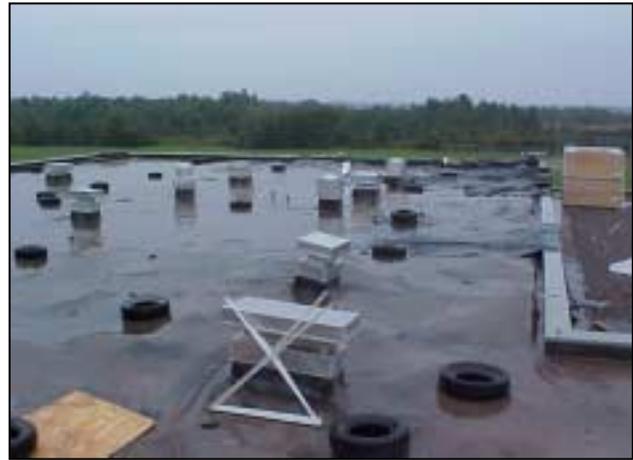
**Figure S-4. Roof decking is uneven, insulation boards are uneven under roof membrane, and vents/fan cowlings are damaged. (Note: Gravel ballast was removed so repairs could be preformed.)**

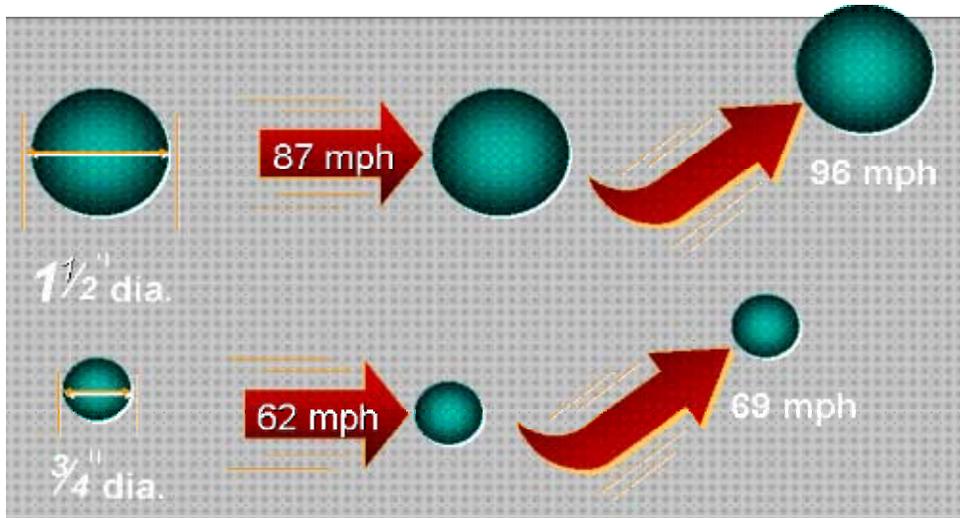
**Figure S-5. Wind speed required to displace and lift aggregate roof ballast into the air.**

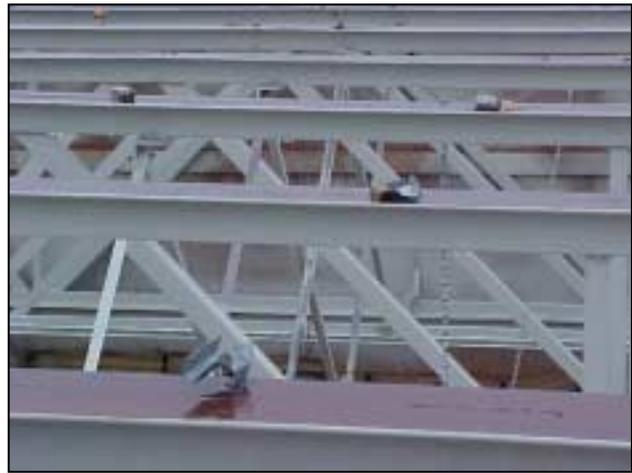
**Figure S-6. Clips from the tectum roof deck system at the gymnasium. The loss of the roof deck was a result of the inability of these clips to restrain the deck or the failure of the deck itself at the clips.**

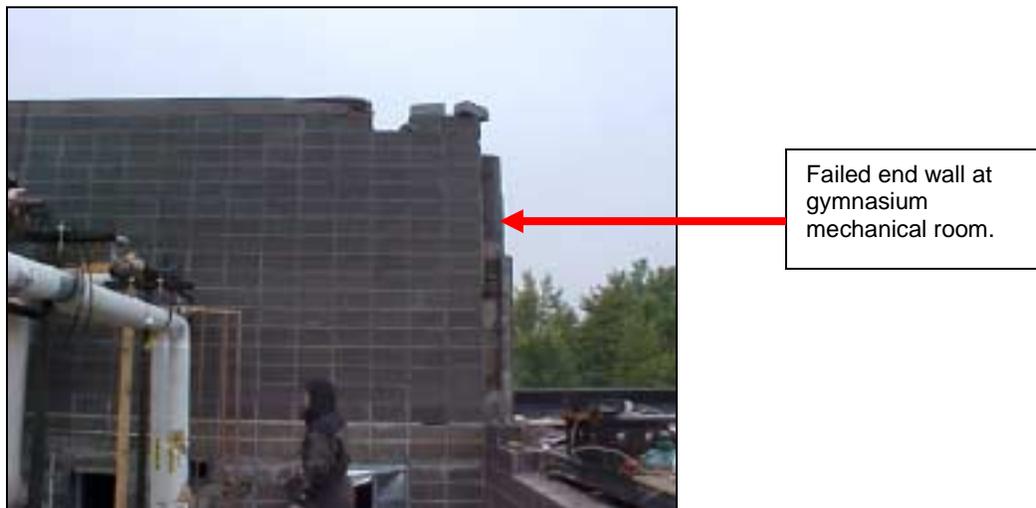
**Figure S-7. The non-load bearing endwall in the mechanical room (missing from right side of photo) at the gymnasium failed from lateral wind pressures and instability at the top of the wall caused by the failed roof decking.**

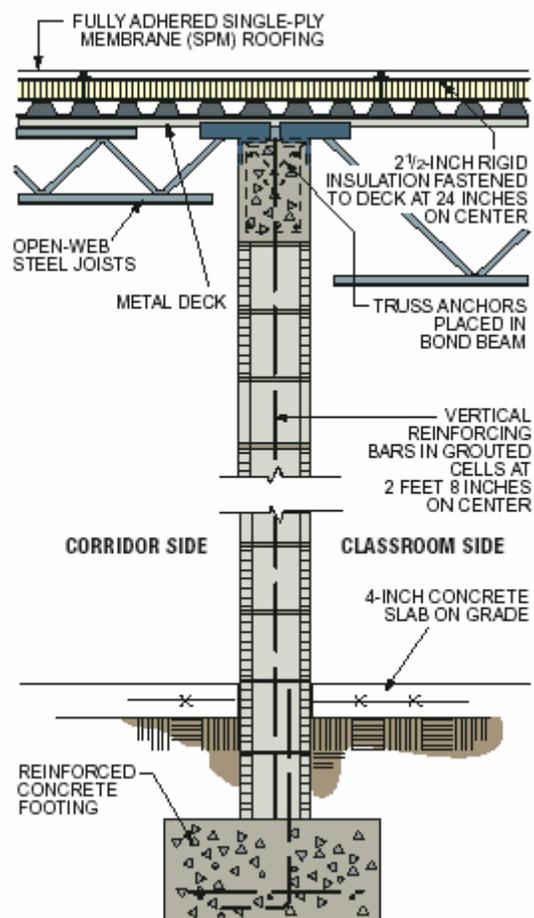
**Figure S-10. Example of a typical wall section providing improved resistance to wind uplift loads. (Tornado Protection: Selecting Safe Areas in Schools, Florida DCA, March 2002)**

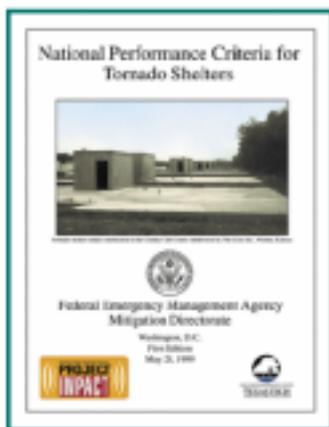
#### **FEMA NPC National Performance Criteria for Tornado Shelters**

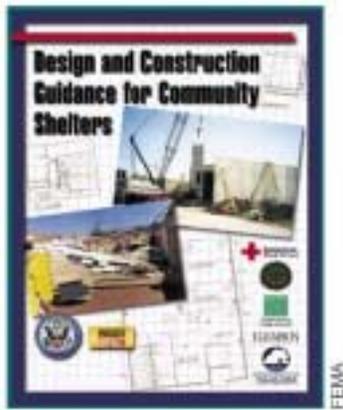
### **Design and Construction Guidance for Community Shelters**
